GENESIS ENGINEERING INC.

Subject: Cruise Ship Volendam Tests – May 24, 2006

Two ozone sterilization tests were carried out aboard the Volendam cruise ship on May 24, 2006. The objective was to determine the efficacy of ViroForce technology for destroying pathogens similar to the deadly Norfolk virus. This report summarizes the procedure that was used during the tests and the conditions to which the test viruses were exposed.

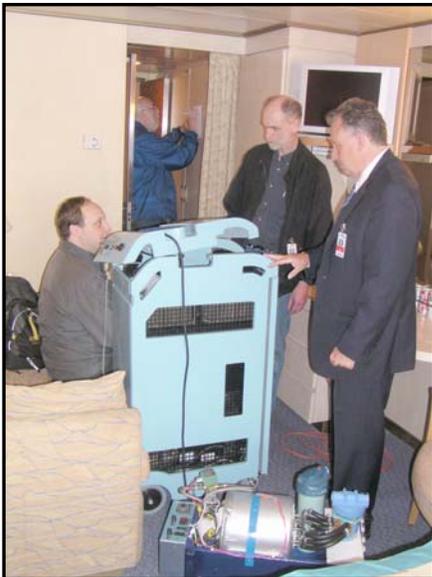
The ViroForce ozone generator/catalytic-scrubber prototype and the rapid humidifier prototype were placed on the floor within the cabin as shown in the photo to the left. Room vents were sealed off with duct tape to prevent any ozone from escaping the cabin. The cabin dimensions were measured and the cabin volume was calculated to be 1308 cubic feet.

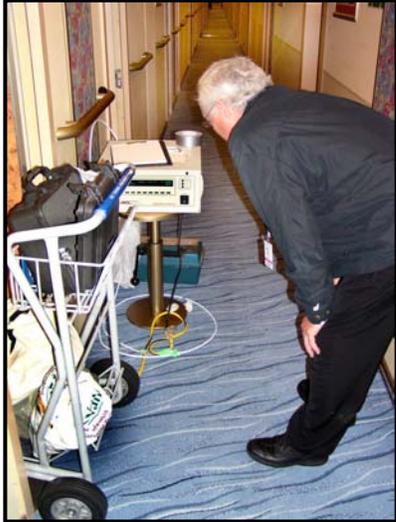
The ozone generators/scrubber and humidifier were actuated via a timer after the test pathogens were placed in the room at random locations and the room was sealed. The ozone concentration, humidity and temperature within the sealed room were monitored from outside the sealed room (photo next page).

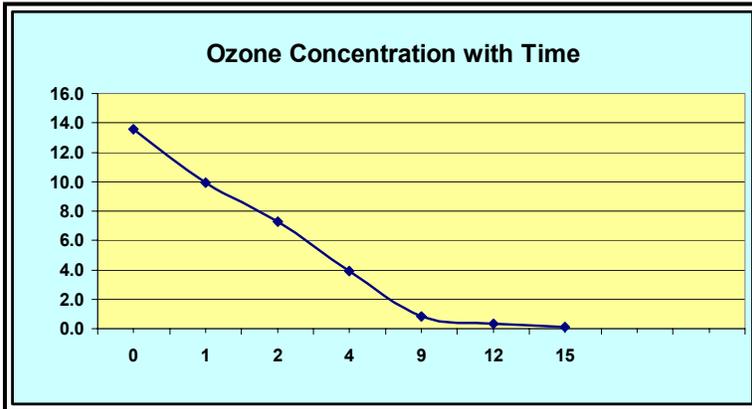
from 25 ppm down to 14 ppm, while the relative humidity went from 66% down to 52%. Following the soak period the catalytic scrubber was turned on and the ozone concentration was reduced from 14 ppm down to 0.2 ppm.

Computer modeling and curve fitting of the data indicates that one of the two fans within the ozone catalytic scrubber was operational during the test. However, even with only one fan operational it took less than 15 minute to lower the ozone concentration down to a safe level (0.25 ppm), as shown in the above graph.

The ozone generators flooded the room at a calculated rate of 11.5 g/hr of ozone. At the end of 30 minutes the ozone concentration within the room had attained a value of 31 ppm (see attached table). The ozone generators were then shut off and the rapid humidifier was turned on for 4 minutes. During this brief time the O₃ concentration went from 31 ppm down to 25 ppm and the relative humidity rose from 37.9% to 66%.

During the 10-minute “soak” period the ozone concentration within the room dropped

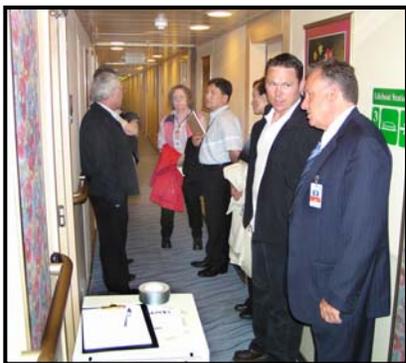
Staff from Health Canada was present to inspect the ViroForce technology and to witness the test procedures for the first test.
