GENESIS ENGINEERING INC.

Subject: St. Regis Hotel Tests – April 26, 2006

Ozone tests were carried with the ViroForce prototype using a room in Vancouver's classic heritage hotel, the St. Regis Hotel, as a test cabin. This room is thought to be representative of the size of a typical cruise ship cabin. The windows and vents of the room were sealed with polyethylene film prior to the tests.

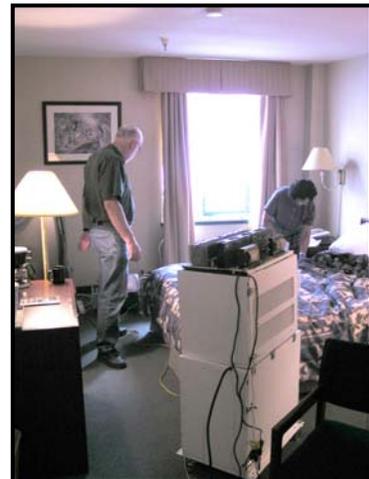
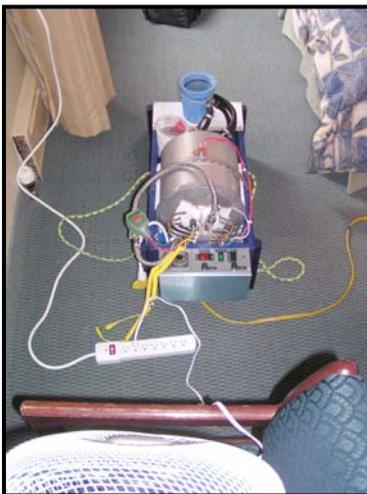
The ozone generator/scrubber prototype was placed within the main room near its entrance door (photo to the right, above), while the rapid humidifier prototype was placed on the floor near the entrance to the bathroom (photo to left). A large fan circulated air, from the bathroom, above and over the humidifier (photo to right).
